LAKE ALEEDA DAM

NDI ID NO. PA-00557

PHASE I INSPECTION REPORT  
NATIONAL DAM INSPECTION PROGRAM

MAY 1979

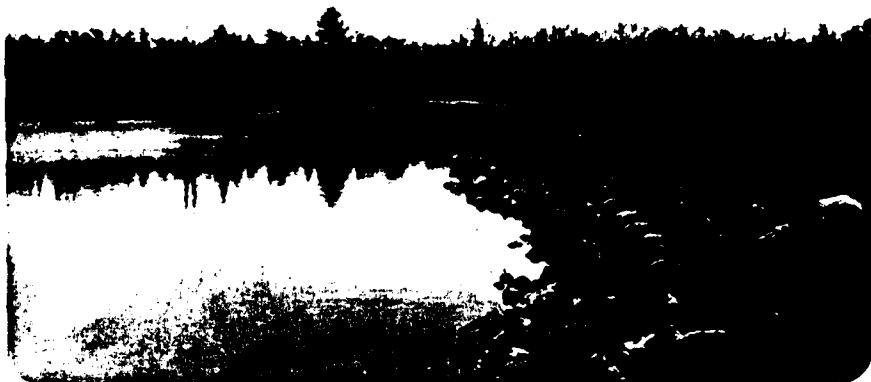
A. Upstream Slope

b. Embankment. The embankment appears in good condition. The grass cover is in good condition, as is the riprap on the upstream slope. The upper part of the upstream slope is covered with a thin layer of fill, as noted previously (Photograph A). A loose shale fill covers most of the downstream slope (Photograph D). This fill is warped around the outlet pipe on a fairly steep slope. Low brush is growing sporadically on both slopes. A small tree is growing at the junction of the auxiliary spillway and the embankment (Photograph G). At the junction of the embankment and the auxiliary spillway, the embankment has no protection from erosive flow in the auxiliary spillway. Trees are growing close to the toe to the right of the main spillway. Two seepage areas were observed. The first is at the downstream toe, just to the right of the conduit (Photograph D). The Owner reported that this is the outlet of the toe drain, which was installed as a modification to the dam. A clear flow of 2 to 3 gpm was discharging from the pipe. "Yellow-boy" precipitate was noted in this area. The second seepage area is at the left bank of the natural channel, about 50 feet downstream of the toe. Clear flow, with "Yellow-boy" precipitate, of 0.5 gpm was observed.

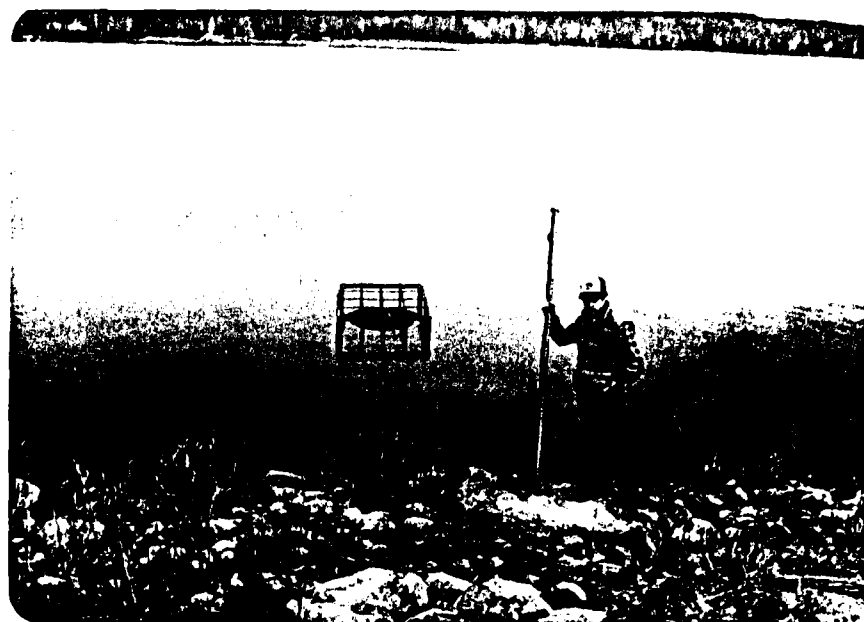
C. Main Spillway and Gate Stem

c. Appurtenant Structures. The main spillway appears in good condition. It was not possible to inspect the riser or conduit because of their small size and because of the flow on the day of the inspection. As noted in Appendix B, the downstream invert of the conduit is apparently 3.0 feet below its design elevation. The only visible part of the outlet works is the gate stem (Photograph C). It is rusty and has obviously not been operated recently. The Owner stated that it has not been operated since the dam was constructed. He declined to operate the outlet works because of his concern that it might remain in the open position, thus drawing down the reservoir.

VISUAL EXAMINATION OF	OBSERVATIONS	REMARKS OR RECOMMENDATIONS
CRACKING AND SPALLING OF CONCRETE SURFACES IN OUTLET CONDUIT	A	
INTAKE STRUCTURE	SUBMERGED	
OUTLET STRUCTURE		
OUTLET CHANNEL		
EMERGENCY GATE	GATE STEM IS RUSTY.	OWNER DECLINED TO OPERATE GATE. HE FEARED THE GATE WOULD BE STUCK OPEN.

(4) Institute a program of detailed annual inspections by a professional engineer experienced in the design and construction of dams. Use the results to determine if remedial measures are necessary. The first inspection should include the conditions in the riser and conduit. Draw down the pool, if necessary, to accomplish this.

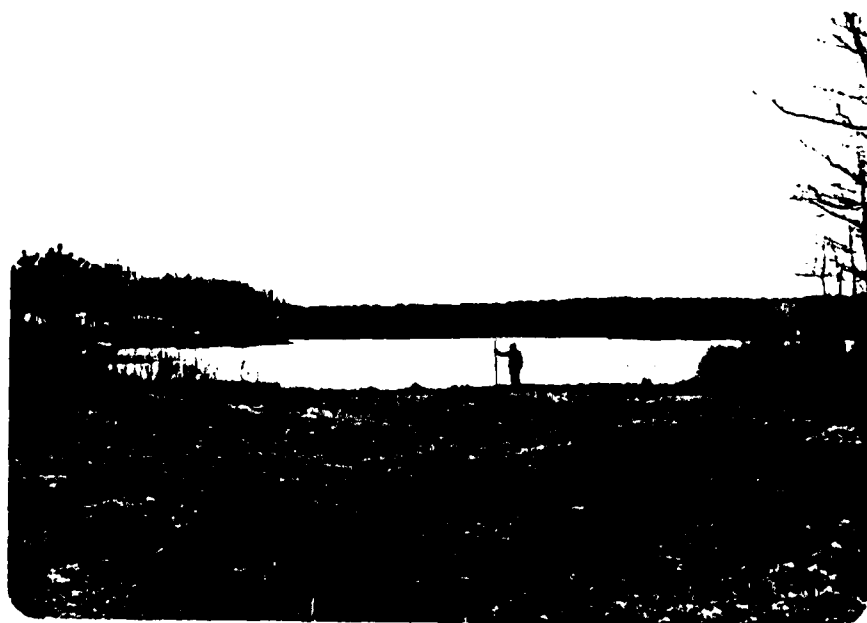
F. Auxiliary Spillway Approach Channel

VISUAL EXAMINATION OF	OBSERVATIONS	REMARKS OR RECOMMENDATIONS
CONCRETE SILL	GRASS - LINED CHANNEL UNEVEN GRADING	
APPROACH CHANNEL	SHORT GRASS-LINED CHANNEL. WET AND SOFT IN AREAS	WET AREA IS ABOVE POOL ELEVATION.
DISCHARGE CHANNEL	FLOW WOULD TRAVEL ALONG EMBANKMENT TOE.	
BRIDGE AND PIERS	NONE	
GATES AND OPERATION EQUIPMENT	NONE
